# slag Successes

## Wilmington VA Hospital puts all its slag in gabion baskets and it works

## In the SE corner of Idaho, not far from the Old Oregon Trail, slag-filled gabions keep erosion at bay

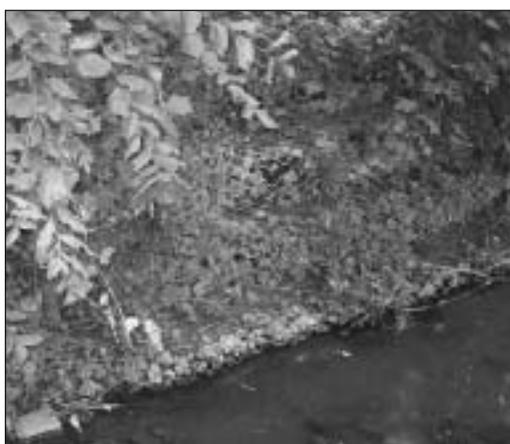
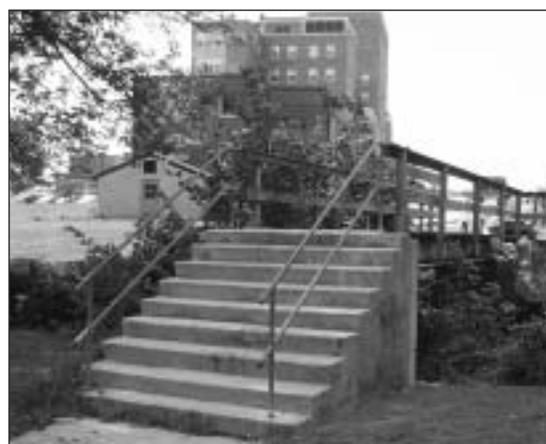
*Wilmington, DE Veterans Administration Hospital project, 2" to 4" steel slag in gabion baskets.*

In this case, steel slag was used. Why slag? Its angular 'particle shape' provides stability to the stream bank. Those same angular shapes create a high angle of internal friction, preventing erosion.

The density of the slag-filled gabions give the stability needed to support the soil under the concrete steps, supporting the bridge structure and the people who cross it. Because steel slag is not affected by freezing and thawing, its use along creek beds is even more advantageous.

Proof that steel slag doesn't impede growth of vegetation, it was difficult finding an open area to photograph the gabions as they look today.

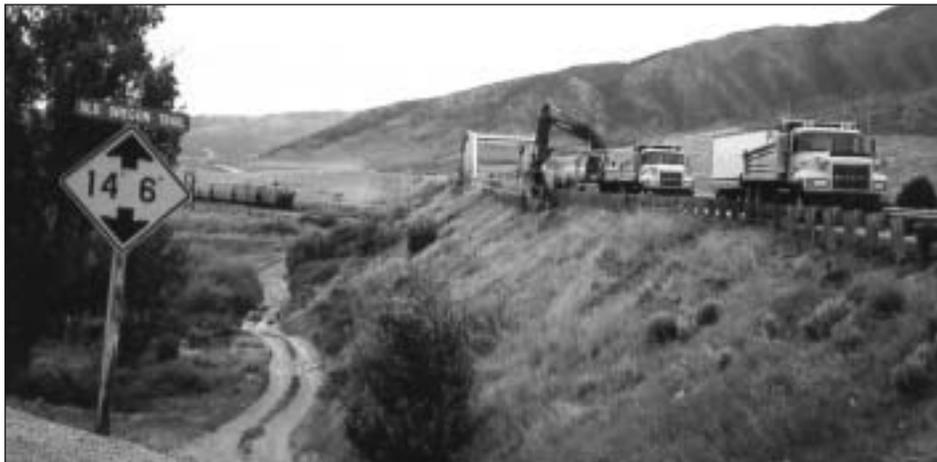
Idaho near McCammon, a bridge crosses the railroad tracks. Both the highway and railroad embankments are subject to erosion by the runoff from rain and/or melting snow. The soils commonly found in the area are fine and granular without a clay binder. That soil type is the least resistant to erosion, espe-

cially since the area is semi-arid and has low vegetation growth which could further protect the slope from erosion. Engineered fill with this soil type was used to build U.S. 30 many years ago and not long ago the Idaho DOT saw a need to repair an eroding section of the embankment.

Placement of the gabion baskets along the highway's shoulder now adds to the stability of the guard rail while allowing for excellent drainage of the roadway through permeable fabric and the open graded steel slag aggregate. This simple but effective repair will protect the shoulder from further erosion.

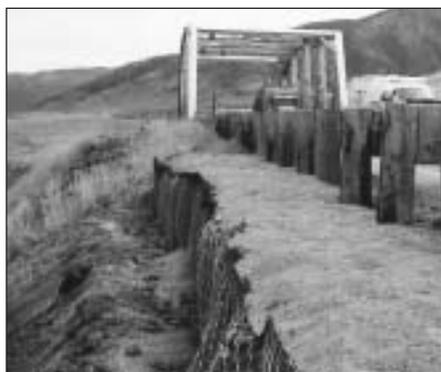
*Slag-filled gabions.*

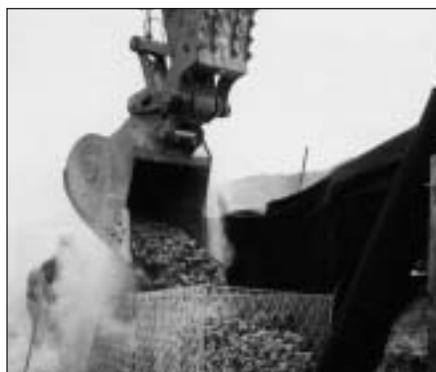
*Filling the baskets with 2"-4" slag.*

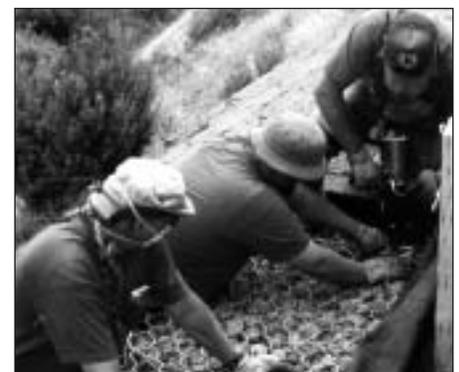
*Road crew secures the gabion baskets.*
